Assembly Instructions Vertical Vinyl Curtain Door “DT2 Quick Reset”

Overview:

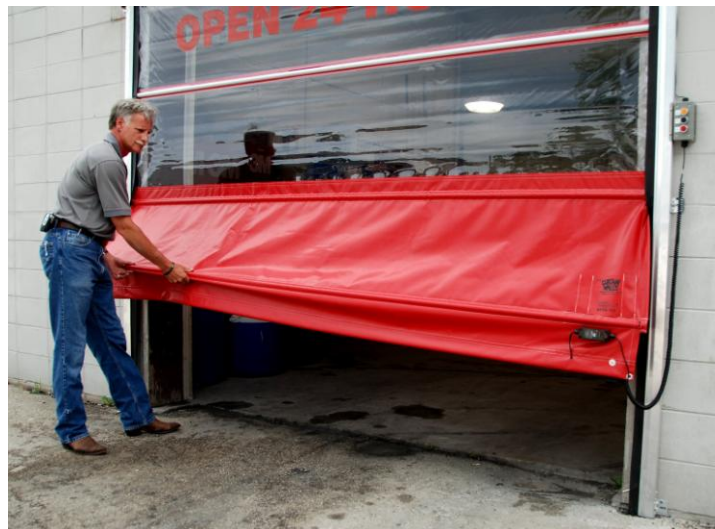
Carefully inspect the door hardware. Ensure that the bracketry has not been bent or damaged and verify that the vertical extrusions are properly aligned with the upper bracket assembly. Repair or replace any damaged components. If the door is completely closed, use the chain hoist or manual crank to open the door approximately one to two feet. **Do not attempt to open the door using the powered operator.** Grasp the bottom of the door and pull it “outward” from the building as shown in the following photo (Photo 1). If multiple pulltrusion have released from their rollers, make sure they are on the “outside” of the aluminum vertical extrusions as well.

Photo #1
(Free Door Material From Opening)

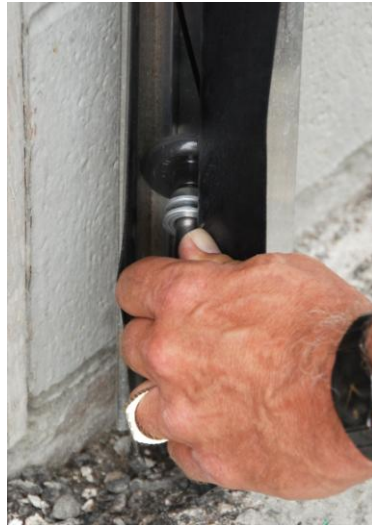
By grasping the shank of a roller and “tilting” it toward the outside of the opening it can be “popped” out of the aluminum vertical extrusion. See the following photo (Photo 2):

Photo #2
(Removing Rollers From Extrusion)

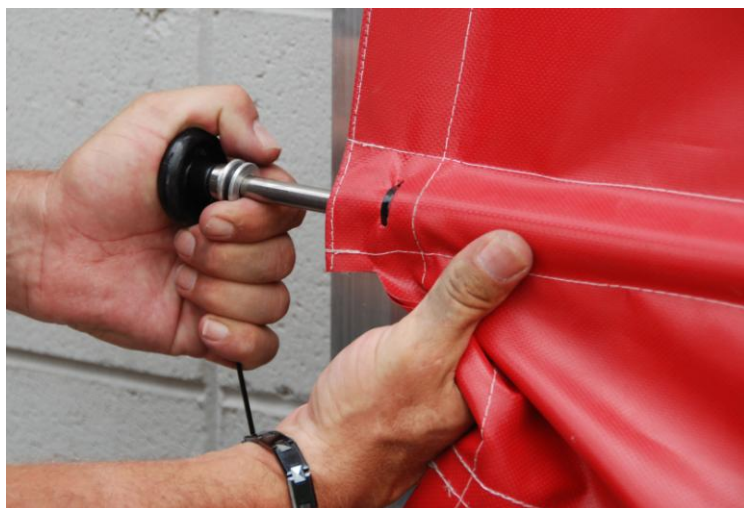
Pull up on the roller and cable and re-insert the stem of the roller into the end of the pulltrusion as shown in the following photo (Photo 3):

Photo #3
(Inserting Roller Into Pulltrusion)

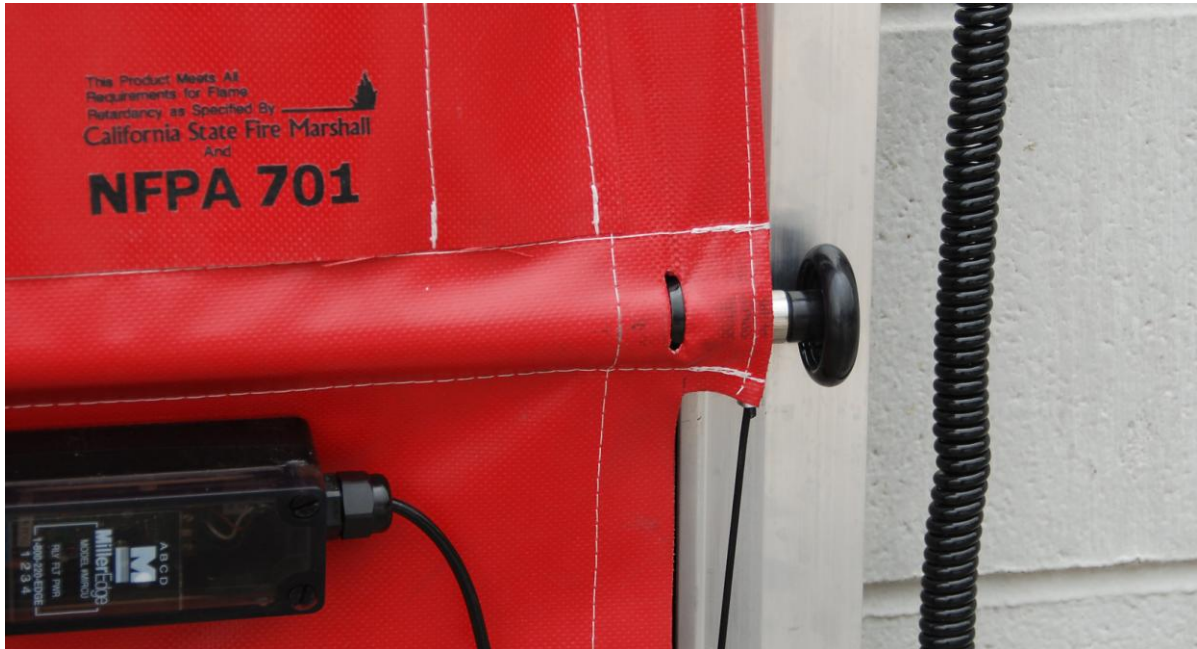
Push the roller all the way into the pulltrusion. Repeat this process for the roller on the other side of the door. When you are done, all released rollers should now be installed in their pulltrusions and they should be resting on the outside surface of the aluminum vertical extrusions as shown in the following photo (Photo 4):

Photo #4
(Roller Fully Inserted In Pulltrusion)

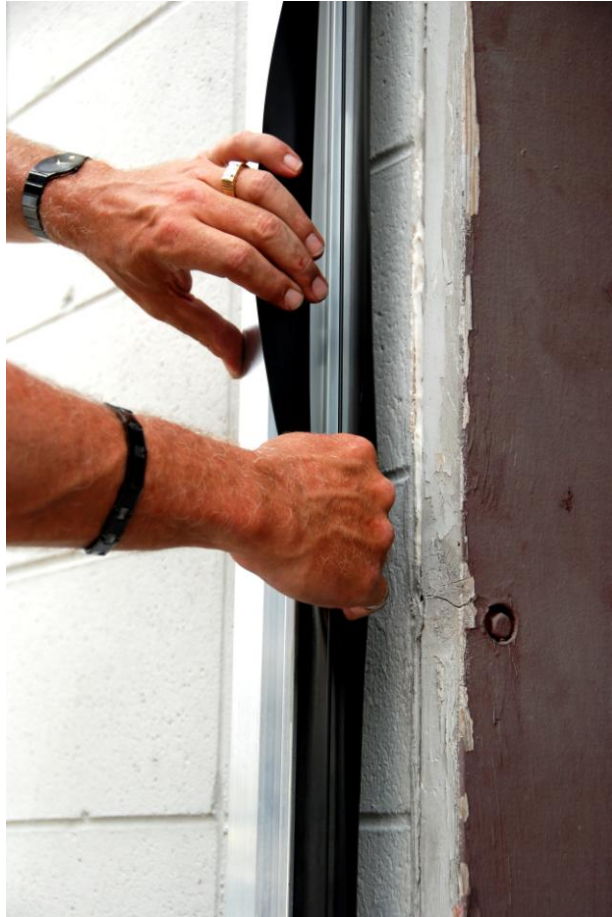
Photo #6

Go down both sides of the door and route the DT2 cable back into the aluminum vertical extrusions. Make sure that the cable is not twisted within the extrusions and that it is properly routed through the lower pulley and the upper pulley next to the “funnel”.

(Routing the DT2 Cable Inside of the Extrusion)
